LIMITED ASBESTOS BUILDING INSPECTION

2412 N Logan Ave
Colorado Springs, CO 80907

April 1, 2015

April 8, 2015

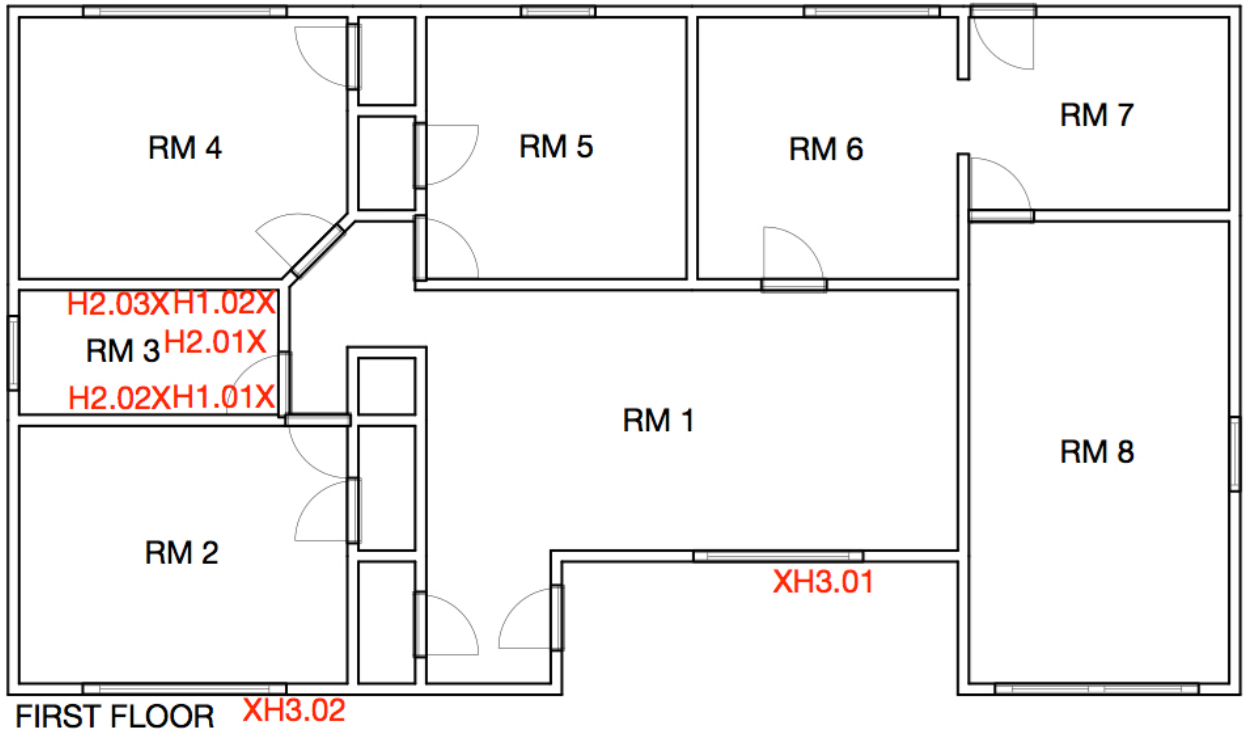
ATTACHMENT A
Building Floor Plan with ACM locations

Bulk sampling conducted during this inspection identified that the joint compound in the bathroom of the property contains asbestos (3% Chrysotile).

Bulk sampling conducted during this inspection identified that the wall and ceiling texture in the bathroom of the property contains asbestos (3-4% Chrysotile).

Bulk sampling conducted during this inspection identified that the window glazing throughout the windows of the garage contains asbestos (.25% Chrysotile).

Please Note: CES recommends all renovation work impacting ACM in the building be completed by an EPA certified and Colorado State licensed General Abatement Contractor (GAC).
